THE DISMASTING OF SASHA

REPAIRING S/V NIMUE'S DECKS

AN OWNER RESTORATION IN THE SAN FRANCISCO BAY AREA

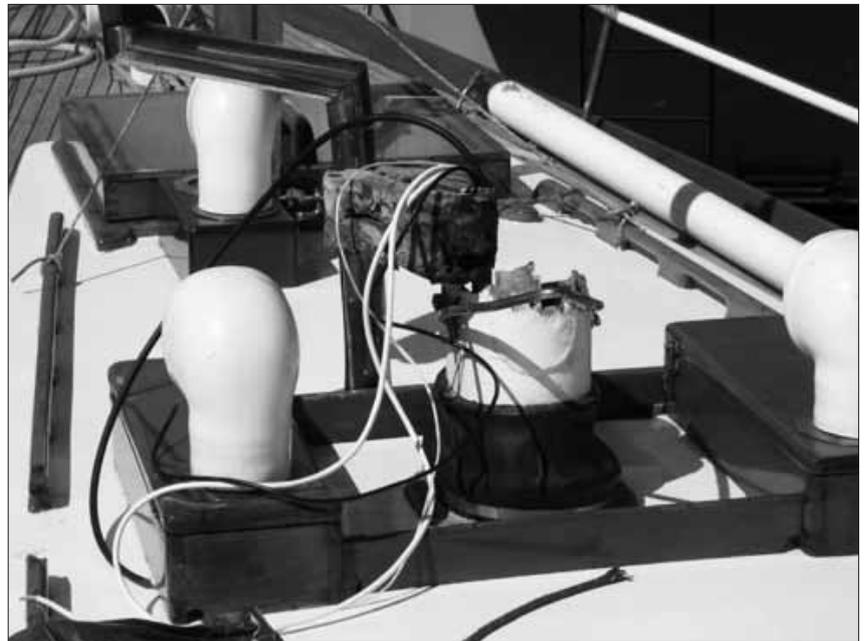
Dismasted! The stump is clearly visible

The trim of the sails, together with the very high pressure applied by the hydraulic backstay on the aluminium mast, the wind speed and the higher halyard track in the strong, cross-running waves resulted in the dismasting of *Sasha*.

Sasha's mast is masthead rigged, a single spreader with no running backstays or lower shrouds aft of the mast position. Because of the pressure from the main the rig is controlled by a baby stay so as not to move aft.

In consequence when falling into a deep and short valley between cross-running waves, the boat's speed decreased sharply, say from 8kn to perhaps 3 kn. Under these circumstances the mast, held securely only at both the top and deck whipped forward due to kinetic energy. The mid-section - the spreader area - is normally held in position by the main sail. If the main sail is eased open - as it was in this situation - the diameter of the aluminium mast should in theory be strong enough in itself to support the mast (e.g. during reefing manoeuvres).

Sasha fell between two waves and 'stopped' with the main sail open; this caused a surge of kinetic energy so strong that the aluminium mast arched forward in the spreader section. The pressure on the aluminium mast, together with the open main and the full wind in the genoa did not allow the mast column to realign before the shock of the next wave, which caused a second shock of energy pushing the midsection further forward and this bent the mast. Then in the following seconds, the

By the way, the new mast for *Sasha* will be made with additional running backstays to avoid dismasting in future (I hope).

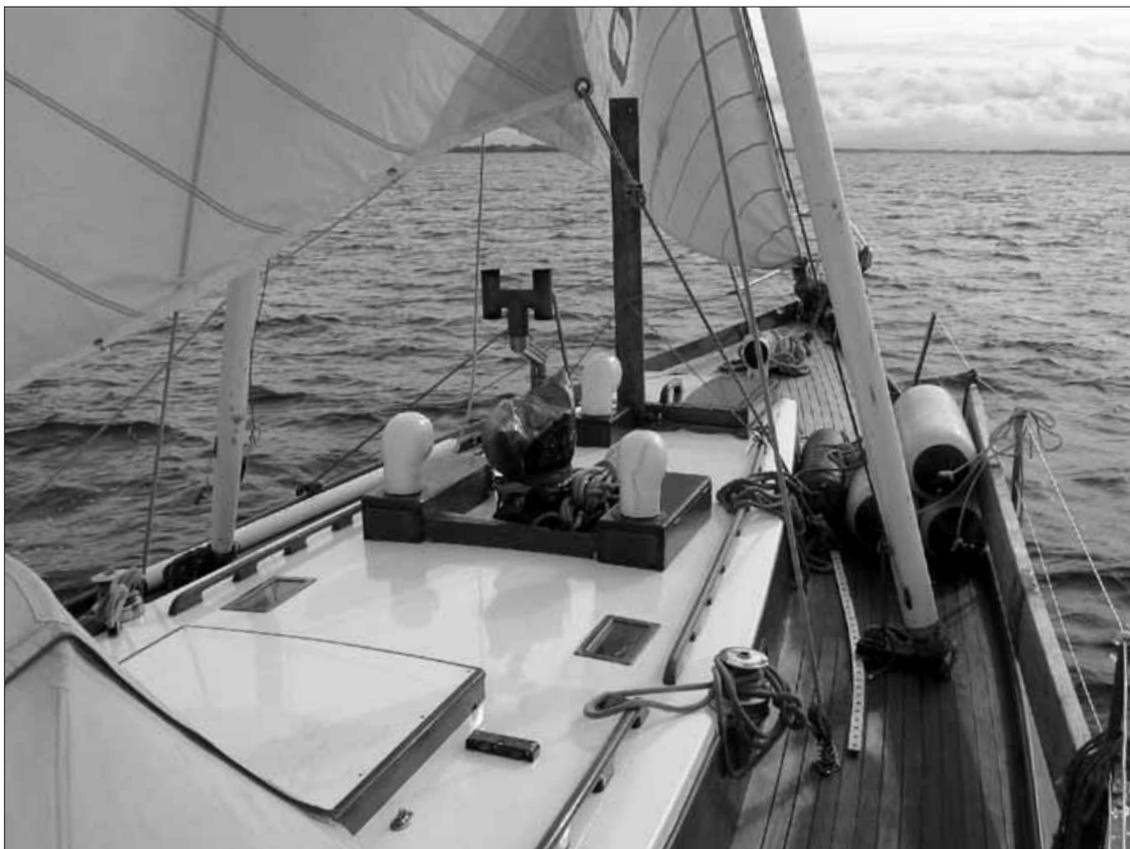
Under jury rig. A spinnaker pole cushioned by fenders and a board acts as a 'mast'
